FULL RESERVE STUDY

Myrtle Beach Villas II

Homeowners Association, Inc.

Myrtle Beach, South Carolina
November 29, 2018

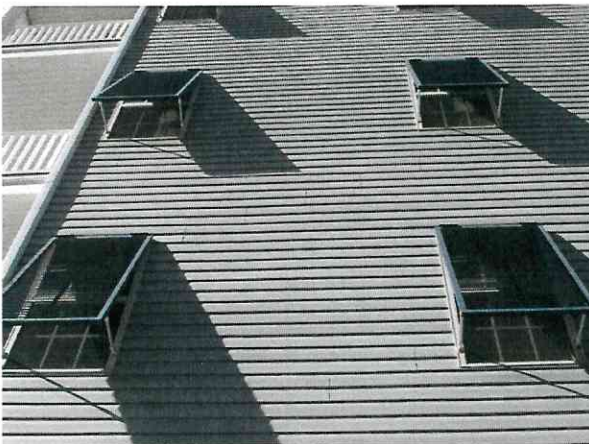
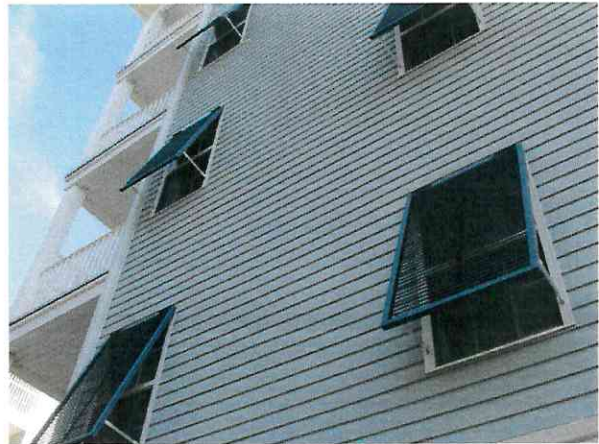
Condition: Good overall

Aluminum awnings

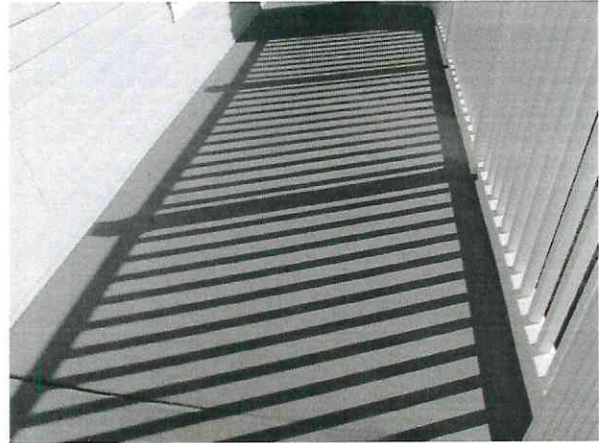
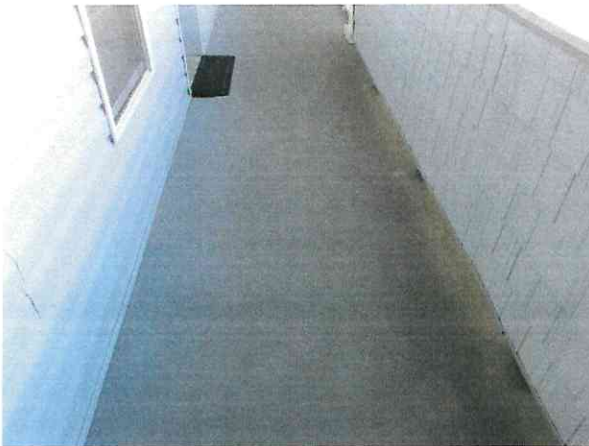
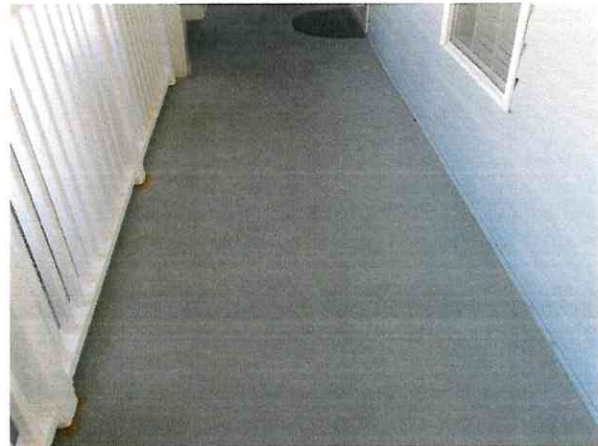
Condition: Good overall

Waterproof coating at concrete breezeway

Useful Life: Capital repairs including a close-up visual inspection, patching of delaminated concrete, routing and filling of cracked concrete, and waterproof coating applications every 8- to 12-years.

- Partial depth replacement of less than one percent (0.5%) of the concrete topsides, edges and undersides
- Crack repairs as necessary
- Repairs to the railings as necessary
- Replacement of perimeter sealants as needed
- Application of a waterproof coating (Urethane based elastomeric)

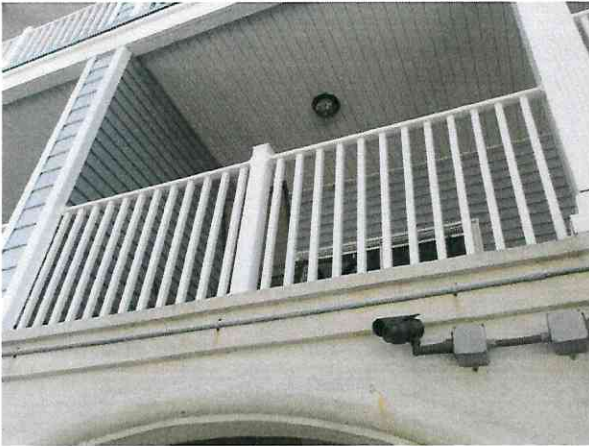
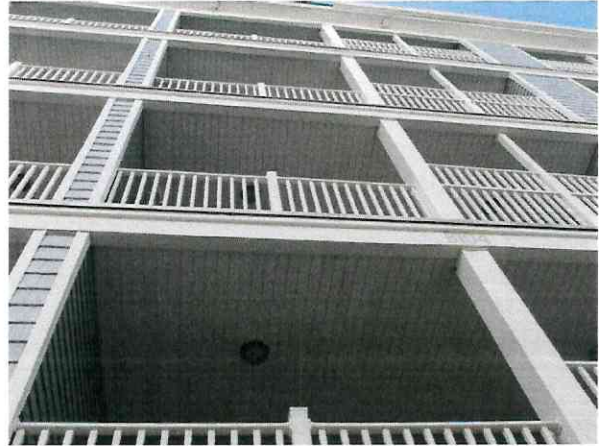
Condition: Good overall condition. Management informs us that there have been stability issues with the small balcony railings and the Association plans to replace them in the near term.

Small vinyl railing at balcony

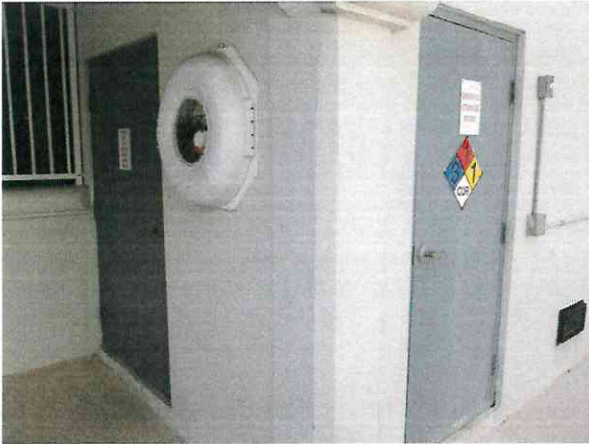
Condition: Good overall with finish deterioration evident at the doors to the pool mechanical rooms. The Association should fund finish applications to the doors from the operating budget on an as-needed basis.

Metal doors at pool mechanical rooms

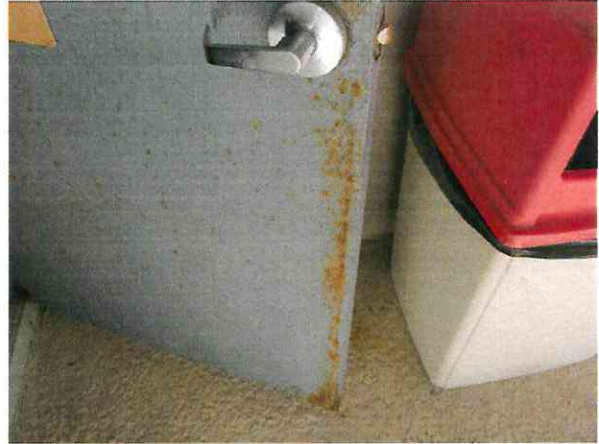
Rust formation at pool mechanical room door

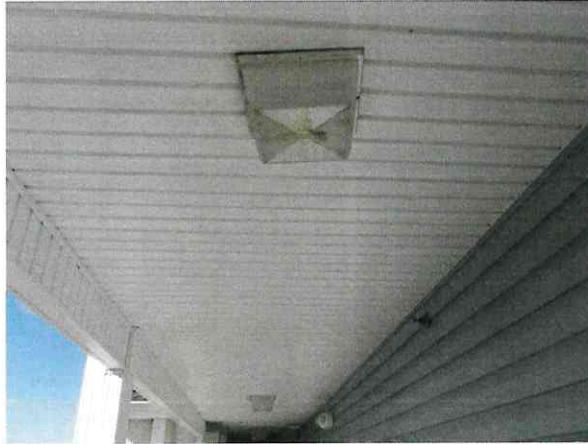
Condition: Management informs us that the Association plans to replace the light fixtures in the near term.

Light fixtures at breezeway

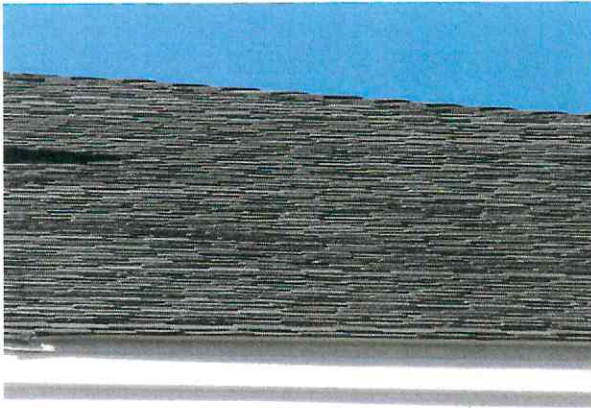
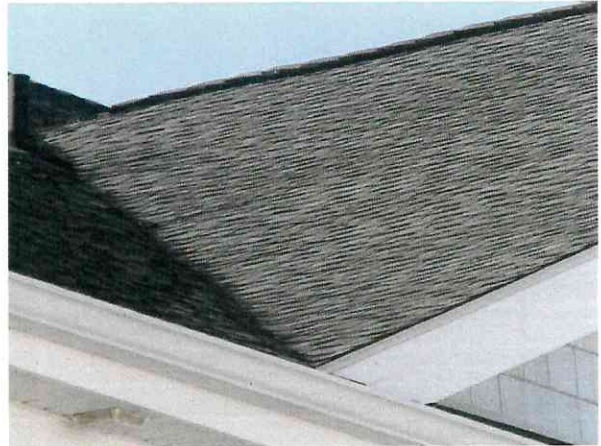
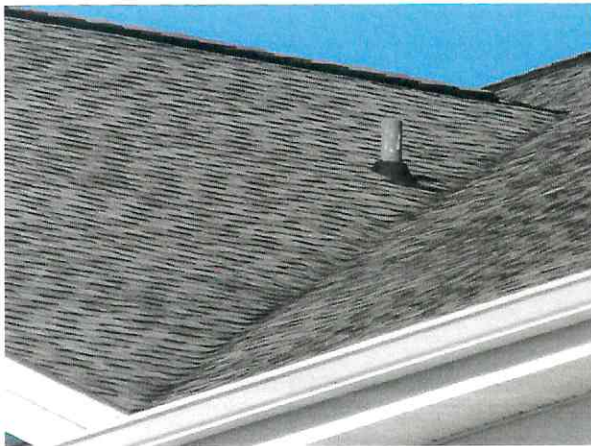
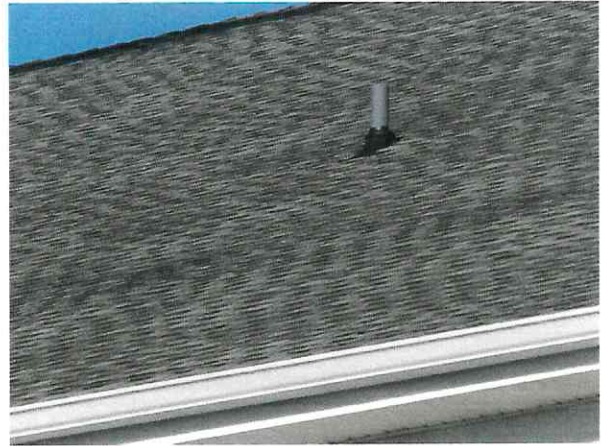
Condition: Good overall with no significant deterioration evident from our visual inspection from the ground.

Asphalt shingle roof

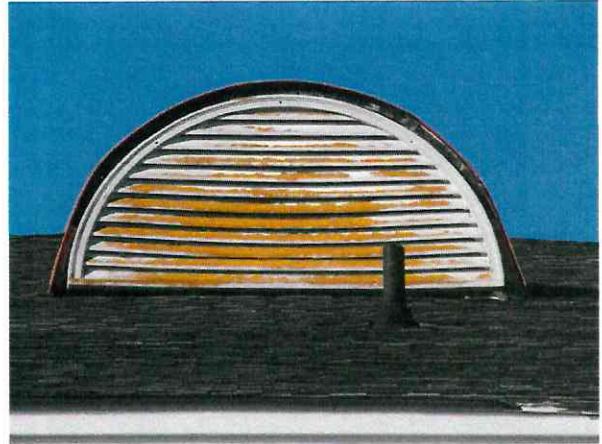
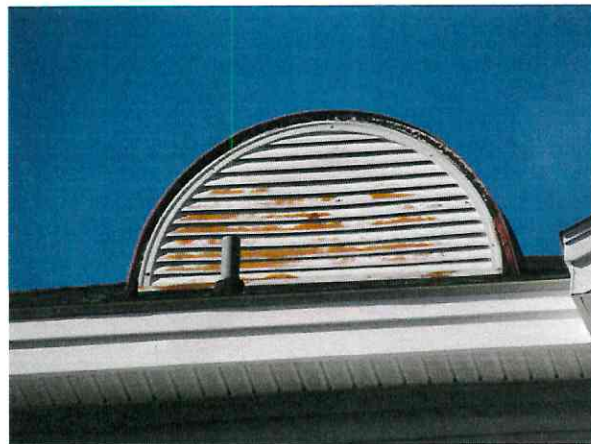
Condition: The metal roofs are in good overall condition. The gables at the roofs exhibit finish deterioration and rust formation.

Finish deterioration and rust formation at dormer gable

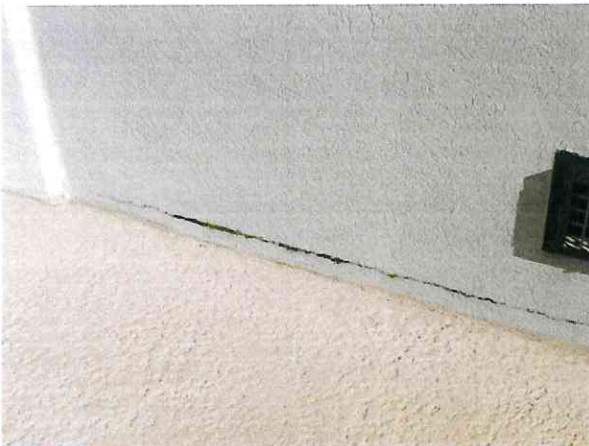
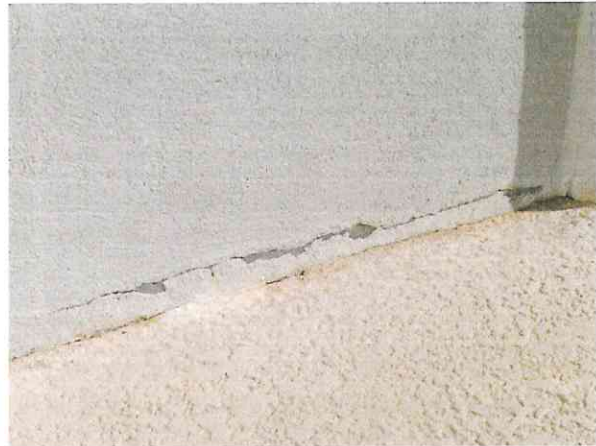
Condition: The condition ranges from good to poor. We note areas of cracked and deteriorated stucco, and stained stucco finishes.

Stucco crack and deterioration at base of exterior wall

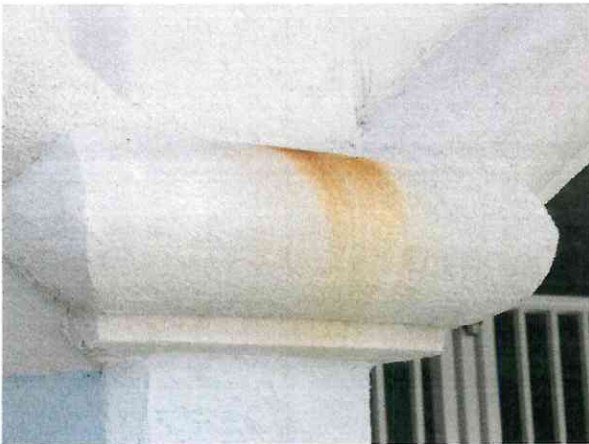
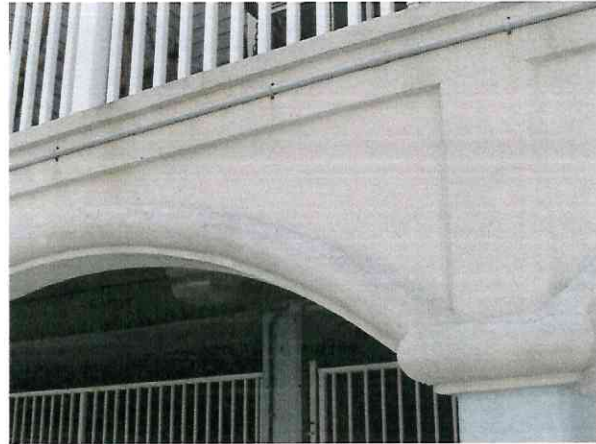
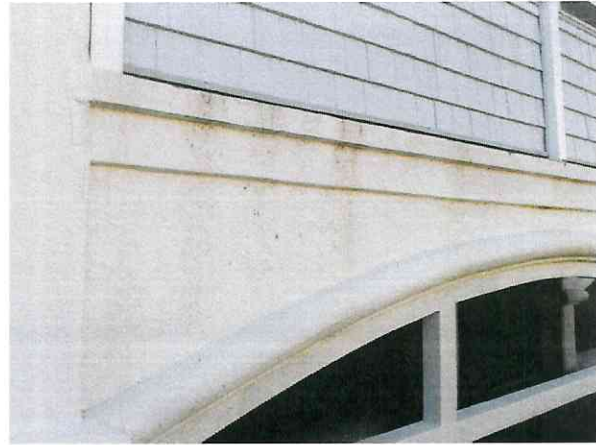
Stain at exterior stucco wall

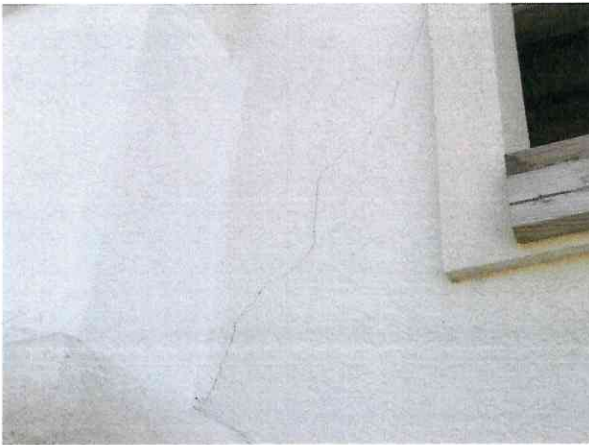
Stucco crack at exterior wall
